# CRAZING

AUTHOR: JOHN BOWMAN – EDITOR(S): NACBI EDUCATION  
COMMITTEE

NACBI Professional Growth & Support System Self-Assessment  
Program Publication

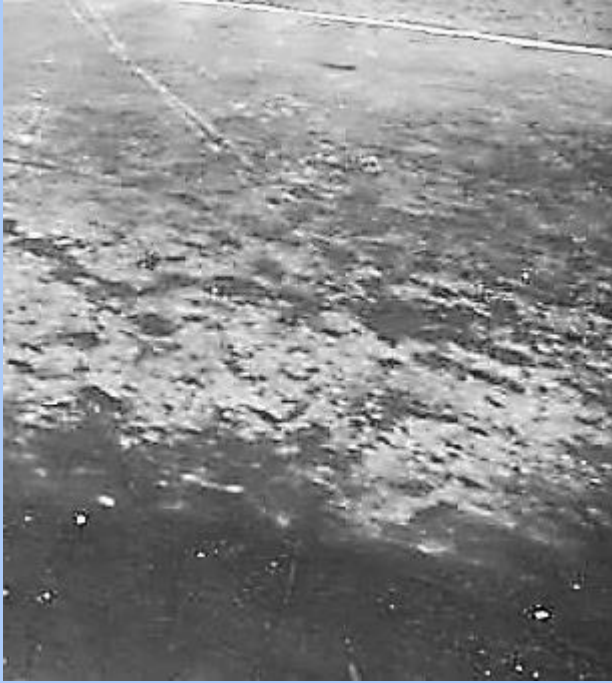
**WHEN DRIED FRESHLY Poured CONCRETE OFTEN LEAVES A WHITE RESIDUE IN THE FORM OF CRAZING.**

Craze cracks develop during the latter stage of the pour and are apparent the day after the pour or at least by the end of the first week. Often, they are not readily visible until the surface has been dampened and it is beginning to dry. When dried freshly poured concrete often leaves a white residue in the form of crazing. (See photo left).

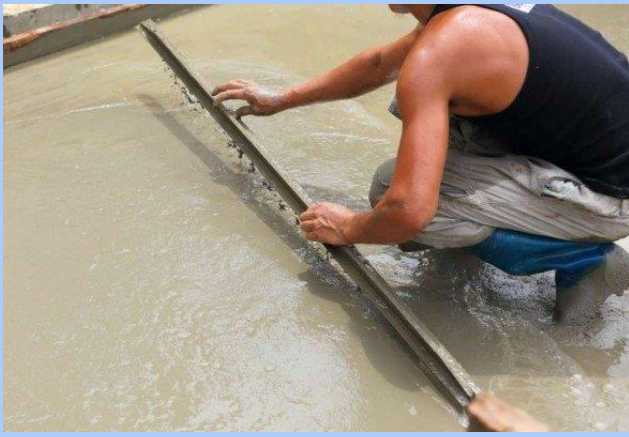
Crazing is a pattern of fine random cracks or fissures on the surface of hardened concrete or mortar caused by drying shrinkage (loss of moisture) of the surface and are usually a cosmetic problem only and is primarily a nonstructural defect. They are barely visible during the construction, except when the concrete is drying after the surface has been wet.

These cracks are rarely more than 1/8-inch (3 mm) deep and are more noticeable on steel troweled finished surfaces.
