GUTTERS

AUTHOR: JOHN BOWMAN – EDITOR(S): NACBI EDUCATION
COMMITTEE

NACBI Professional Growth & Support System Self-Assessment
Program Publication

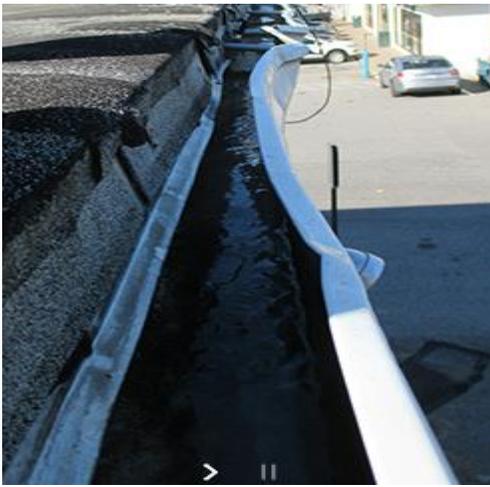
THIS RESIDENTIAL GRADE GUTTER ON A COMMERCIAL BUILDING HAS BEEN BENT AND DAMAGED.

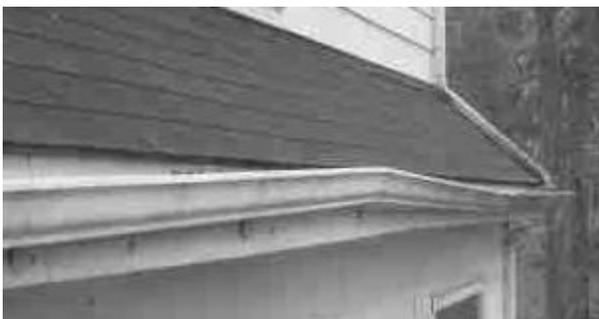
IMPROPER SLOPED GUTTER.
