# METAL ROOF OXIDATION

AUTHOR: JOHN BOWMAN – EDITOR(S): NACBI EDUCATION  
COMMITTEE

NACBI Professional Growth & Support System Self-Assessment  
Program Publication

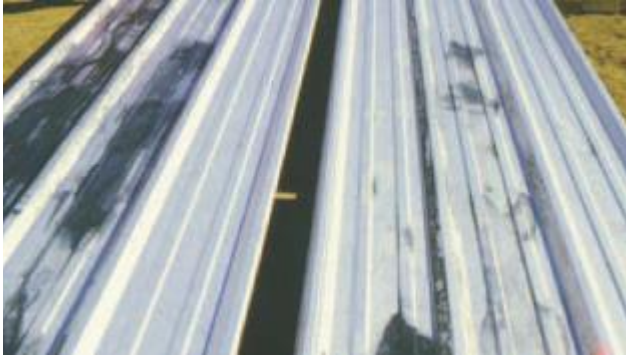
**STAINS ON NEW METAL PANELS DUE TO  
STANDING WATER FROM IMPROPER  
STORAGE**

Oxidation can occur very rapidly when excess water remains or becomes trapped on a metal roof surface. Installers often fail to properly store or provide proper air flow during the storage/construction stages. Certain metal roofs, such as zinc, are highly susceptible to oxidation and should not be installed where there will be standing water and drainage problems.

Zinc and other metal roofing panels can develop a form of corrosion commonly referred to as “white rust” when it is improperly stored and kept wet and unexposed to air. This chalky white powder fails to give protection to the underlying metal.
