CRAZING

AUTHOR: JOHN BOWMAN – EDITOR(S): NACBI EDUCATION
COMMITTEE

NACBI Professional Growth & Support System Self-Assessment
Program Publication

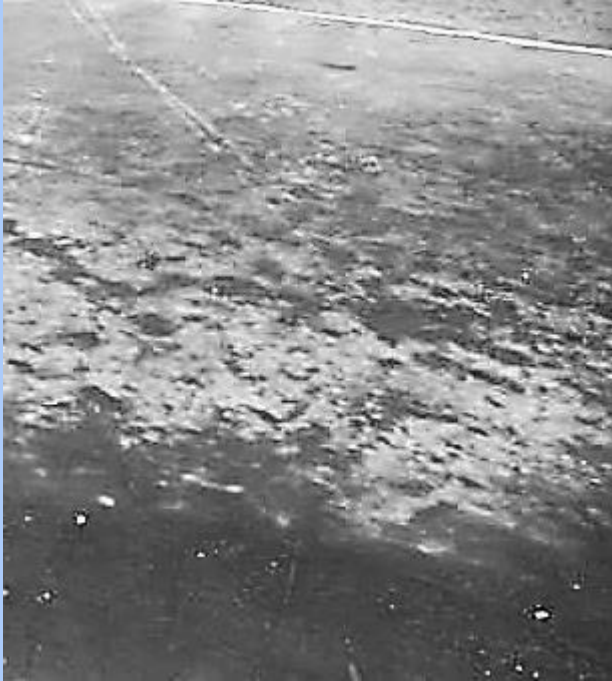
WHEN DRIED FRESHLY Poured CONCRETE OFTEN LEAVES A WHITE RESIDUE IN THE FORM OF CRAZING.

Craze cracks develop during the latter stage of the pour and are apparent the day after the pour or at least by the end of the first week. Often, they are not readily visible until the surface has been dampened and it is beginning to dry. When dried freshly poured concrete often leaves a white residue in the form of crazing. (See photo left).
