METAL ROOF OXIDATION

AUTHOR: JOHN BOWMAN – EDITOR(S): NACBI EDUCATION
COMMITTEE

NACBI Professional Growth & Support System Self-Assessment
Program Publication

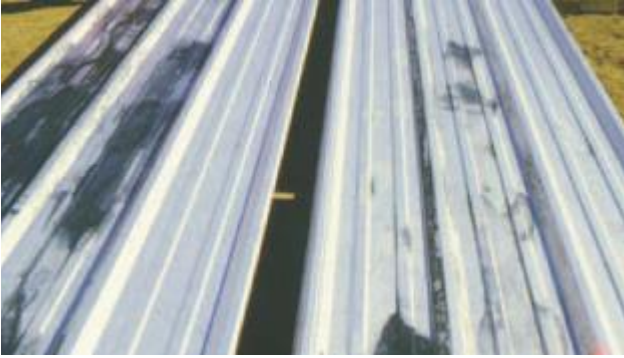
**STAINS ON NEW METAL PANELS DUE TO
STANDING WATER FROM IMPROPER
STORAGE**

Oxidation can occur very rapidly when excess water remains or becomes trapped on a metal roof surface. Installers often fail to properly store or provide proper air flow during the storage/construction stages. Certain metal roofs, such as zinc, are highly susceptible to oxidation and should not be installed where there will be standing water and drainage problems.

Zinc and other metal roofing panels can develop a form of corrosion commonly referred to as “white rust” when it is improperly stored and kept wet and unexposed to air. This chalky white powder fails to give protection to the underlying metal.
